VULNERABILITY ASSESSMENT OF PUERTO GALERA BAY TO CLIMATE CHANGE AS AFFECTED BY ITS BIOPHYSICAL CHARACTERISTICS AND URBANIZATION

Ociones Fe T. *

Abstract

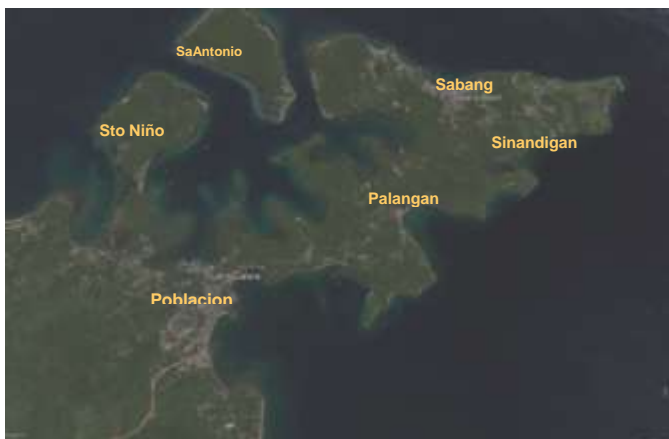
Figure 2. Political boundary map of Puerto Galera Bay (Source: 2015 Google Imagery).

Puerto Galera Bay (longitude 120°56'24" to 121°59'30" East; latitude 13°30' to 13°31'58" North), is located in the north eastern part of the municipality of Puerto Galera in Mindoro Island. It is about 123 km. South of Manila. The total land area is 865.28 hectares (based on map calculations done through GIS). Its irregular coastline that forms series of headlands, promontories and coves is 35 kilometers long, to include its island coastlines. Medio Island which caps the Bay on its northern tip provides two entrances: the Manila Channel on its western seaboard; the Batangas Channel on its eastern side. **Figure 1 and 2** shows the location and political boundary maps of Puerto Galera..

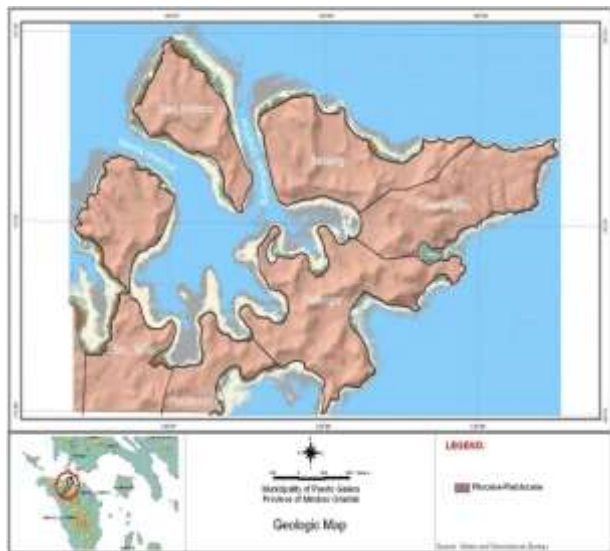
Figure 5. Geologic Map of Puerto Galera Bay (Source: Mines and Geosciences Bureau, DENR)

This geologic base in the lands of Puerto Galera Bay is pliocene-pleistocene (**Figure 5**), which has a high rating in terms of susceptibility to landslide and erosion. **Figure 6** shows the rock arrangement in the molave forest area. This parallel rock formation is prone to landslide and when saturated during heavy storms, the rocks can easily slip thereby triggering a massive landslide.

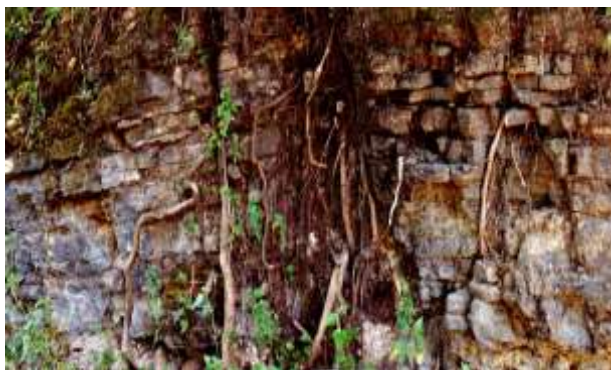
Figure 6 Rock formation in the Molave forest showing a parallel rock formation, which is susceptible to landslide especially during typhoon seasons.

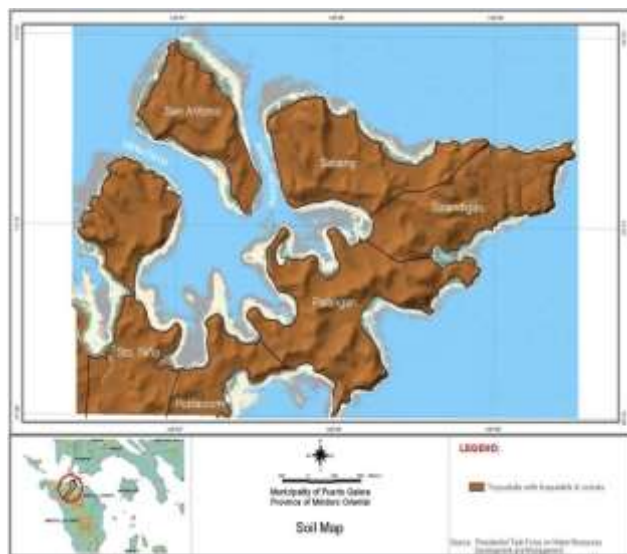
Figure 7 Soil map of Puerto Galera Bay (Source: Bureau of Soils Data)

The technical soil description of Puerto Galera Bay is tropudults w/tropudalfs as seen in figure 7. This type has a very high rating in terms of susceptibility to soil erosion and landslides. The high amount of calcium and magnesium is expected since fieldspar, biotite, calcite and carbonate are the dominant minerals in the area. Data source is from the Philippines Bureau of Soils.

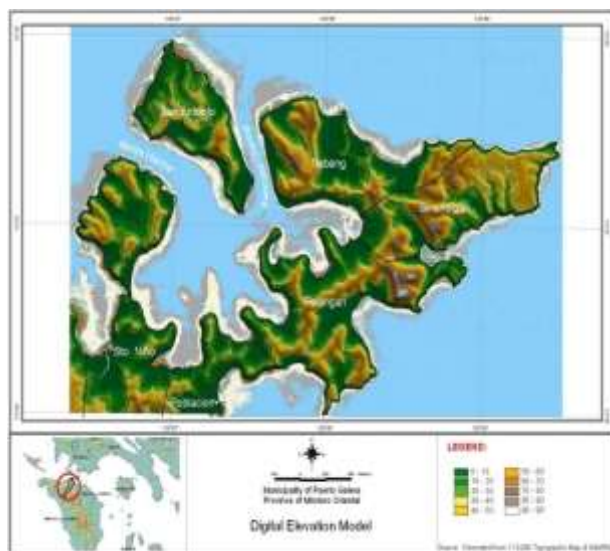
Figure 8 Digital Elevation Model (DEM) extracted from the 1:10,000 topographic map of NAMRIA

The highest elevation in Puerto Galera is 98 meters above sea level located in the mountain peaks of Palangan as seen in the digital elevation model (DEM) of the Bay (Figure8). Elevations and slopes of Puerto Galera Bay were extracted and processed using GIS.

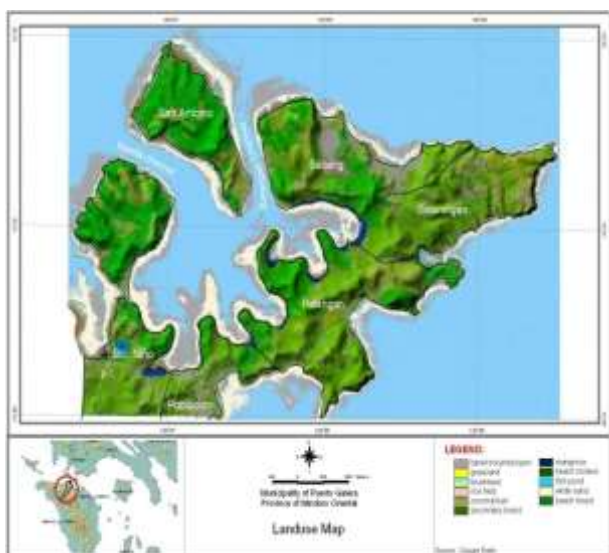
Figure 10 Existing land use map of Puerto Galera Bay delineated from the 2015 Google Imagery

Puerto Galera Bay is dominated by secondary forests and molave beach type forest. These larger tracts of Molave beach forests are located in Sabang, Palangan and Sinandigan, These forests are seen fronting the Coves of the Bays and cover critical areas like promontories and headlands (figure 10). Coconut and buri also covers many areas in the Bay especially in Sabang, San Antonio and Sinandigan and Sto Niño. The barangays of Sabang and poblacion have larger areas used for

residential, commercial and tourist areas while large open and bare areas can be found in Sinandigan, Palangan and Sabang. Existing Landuse map was processed from the Goggle imagery using the multispect which is a remote sensing program.

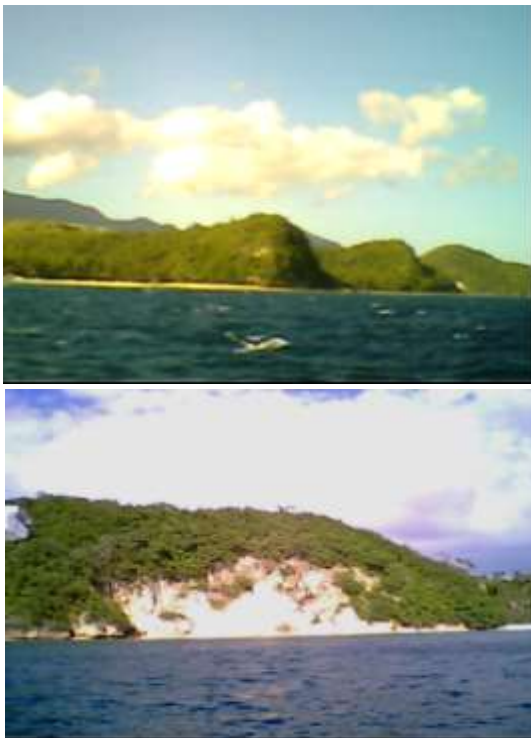
Figure 12 Promontories and cliffs with very steep slopes around the bay are very susceptible to landslides and mass soil movements. Photos show landslide occurrences especially during strong typhoons.

inclement weather (**Figure 12**). One factor that prevents excessive and heavy sedimentation and rampant landslides is the beach/molave and secondary forests that still abound in the bay. It also helps that these types of vegetation and land use covers steep slopes and mountain ridges.

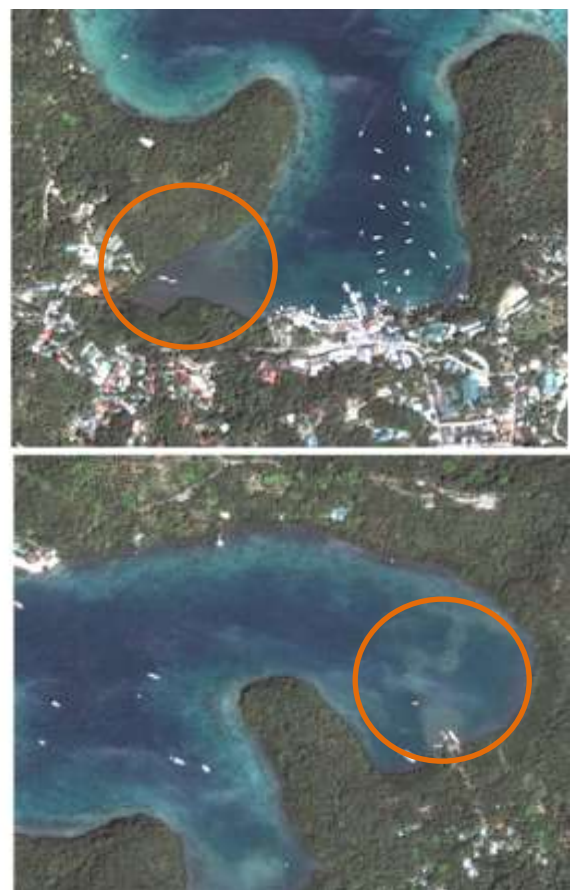
Figure 14 Google imageries of coves inside the bay showing heavy sedimentation due to developments in the upper areas.

clearing for commercial development results in heavy siltation of coastal waters around the immediate vicinities (**Figure 14**)

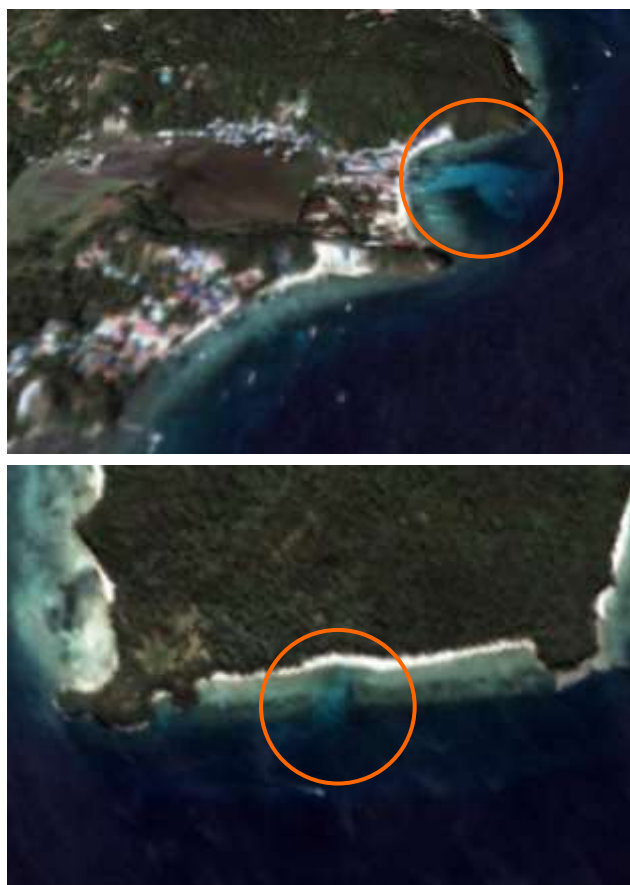
Figure 15. Goggle imageries in 3D landscape show the scouring effects of boats and bancas (shown in orange insets) on the shallow and deep coral portions of the coastal areas in Sabang and San Antonio.

Latest satellite imagery in **Figure 15** shows that aside from sedimentation, other human impacts include scouring of shallow coral reef areas done by bancas docking around the Bay. Local legislation should also cover laws that would prevent or minimize anthropogenic impacts.
